TEST REPORT No. RS00-067

CONCERNING THE FIRE RESISTANCE

Test of fire resistance of foam seals

Material presented by: Société SOUDAL
Trademark: "SOUDAFOAM – FR"
Manufacturer: Société SOUDAL
Origin: TURNHOUT (Belgium)

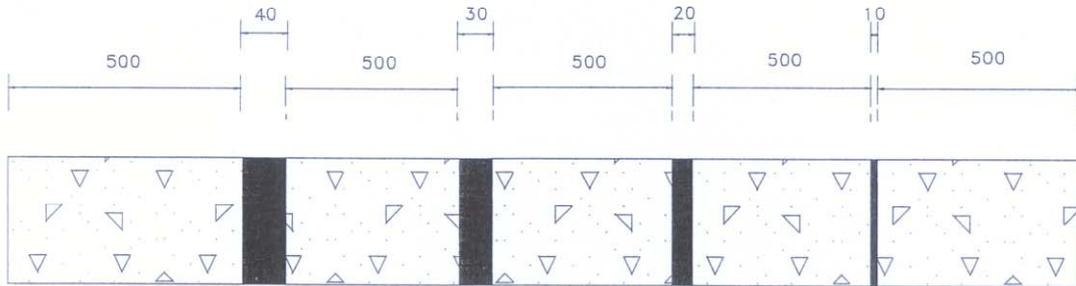
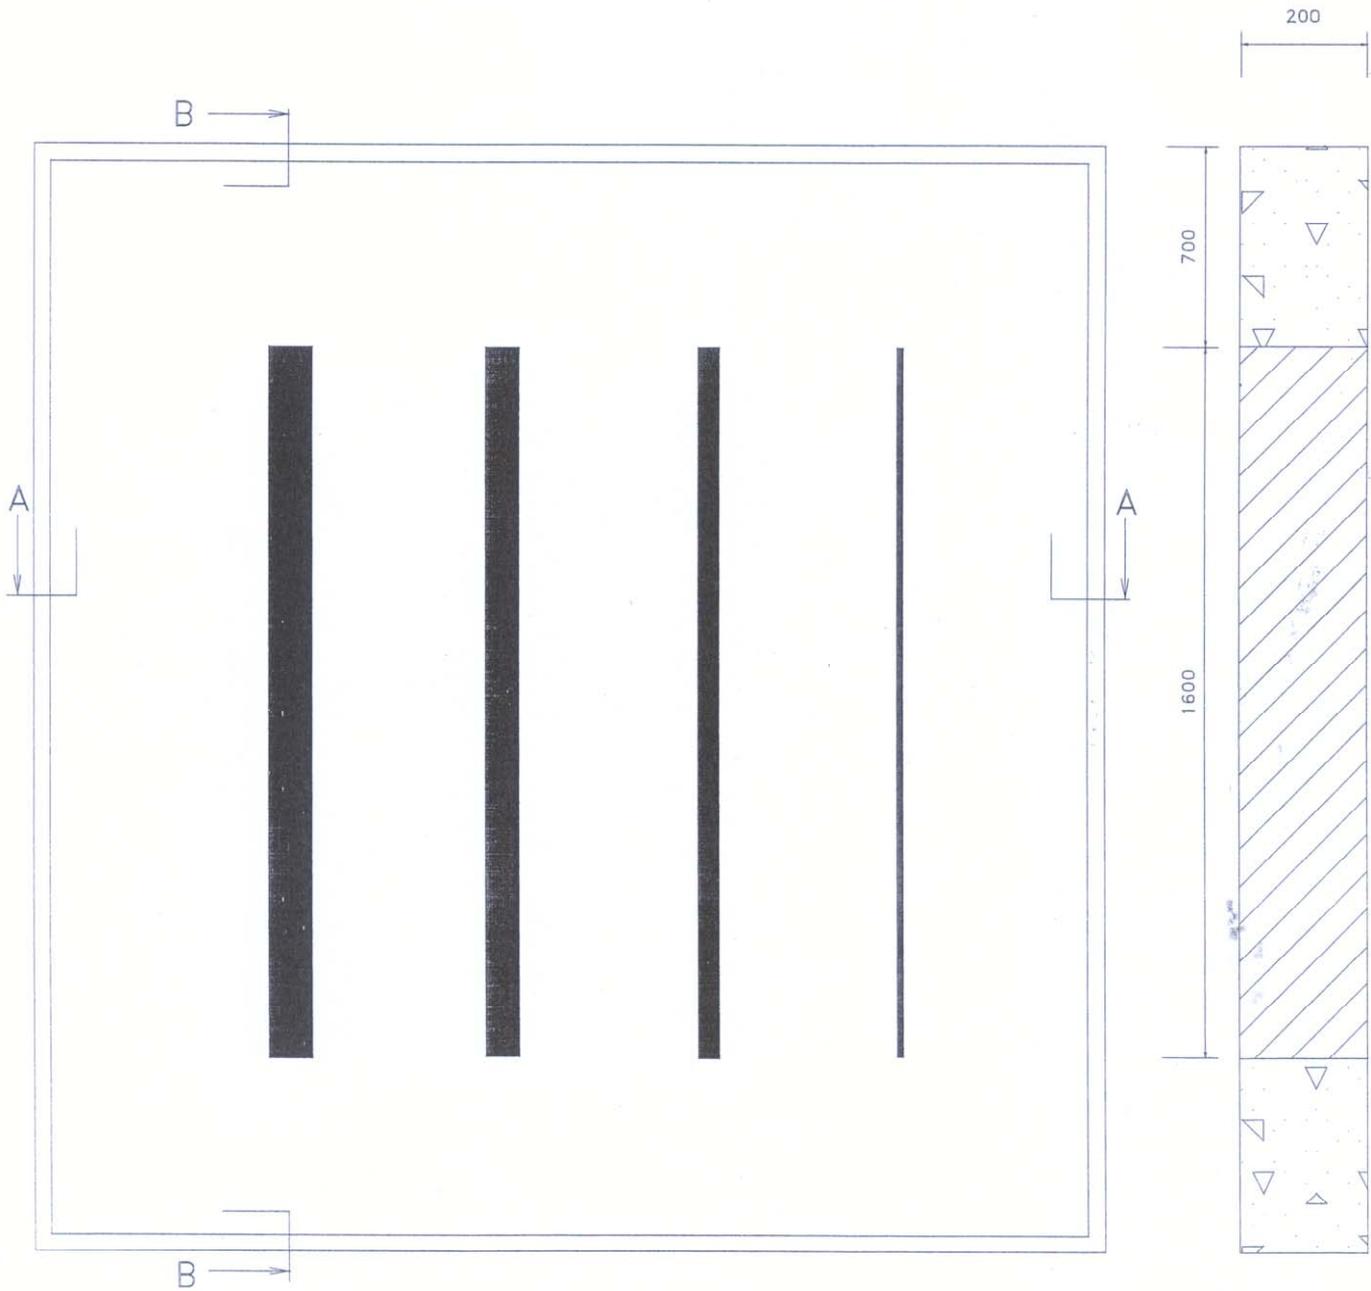
Section A - A

A vertical wall, thickness 200, containing four apertures, for installing the foam seal, height 1600, widths:

- Seal A: 40 mm,
- Seal B: 30 mm,
- Seal C: 20 mm,
- Seal D: 10 mm.

Installing the SOUDAFOAM – FR foam seal begins with the dampening of the rims of the apertures.

Packaged in a spray can, the foam seal is then extruded to repletion.

After drying, the foam surplus is removed and the seals trimmed flush.

- See the drawings of the element, Plate no. 1 –

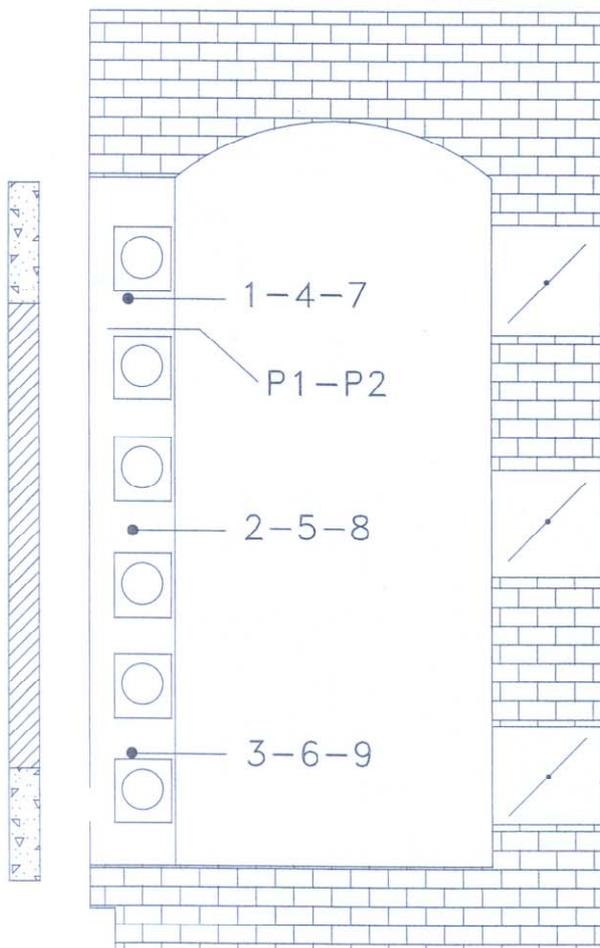
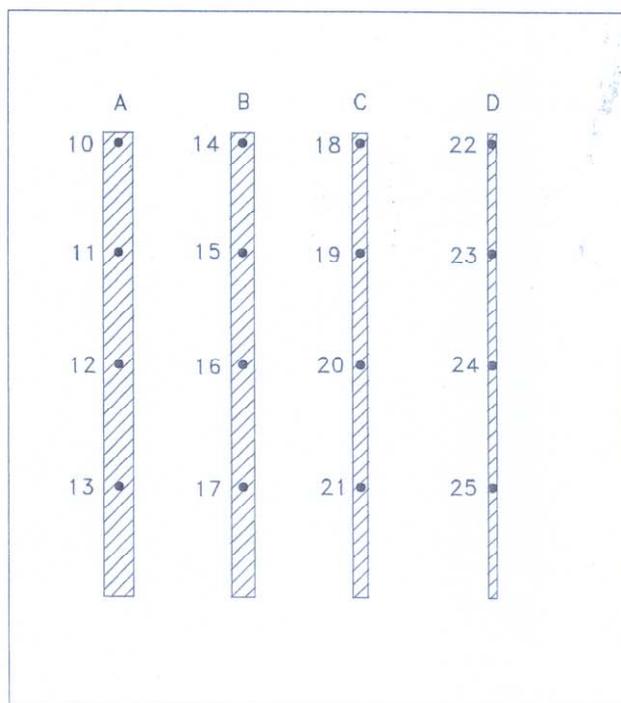
POSITIONS OF THE TEMPERATURE AND PRESSURE SENSORS

- 1 to 9 : Oven temperature, 100 mm from the exposed face
- 10 to 13 : Temperature of the non-exposed face of seal A, 40 mm
- 14 to 17 : Temperature of the non-exposed face of seal B, 30 mm
- 18 to 21 : Temperature of the non-exposed face of seal C, 20 mm
- 22 to 25 : Temperature of the non-exposed face of seal D, 10 mm
- P1 – P2 : Pressure sensors

SECTION OF THE OVEN

NON-EXPOSED FACE

The positions and pinpointing markers of the temperature sensors are indicated on Plate no. 2.

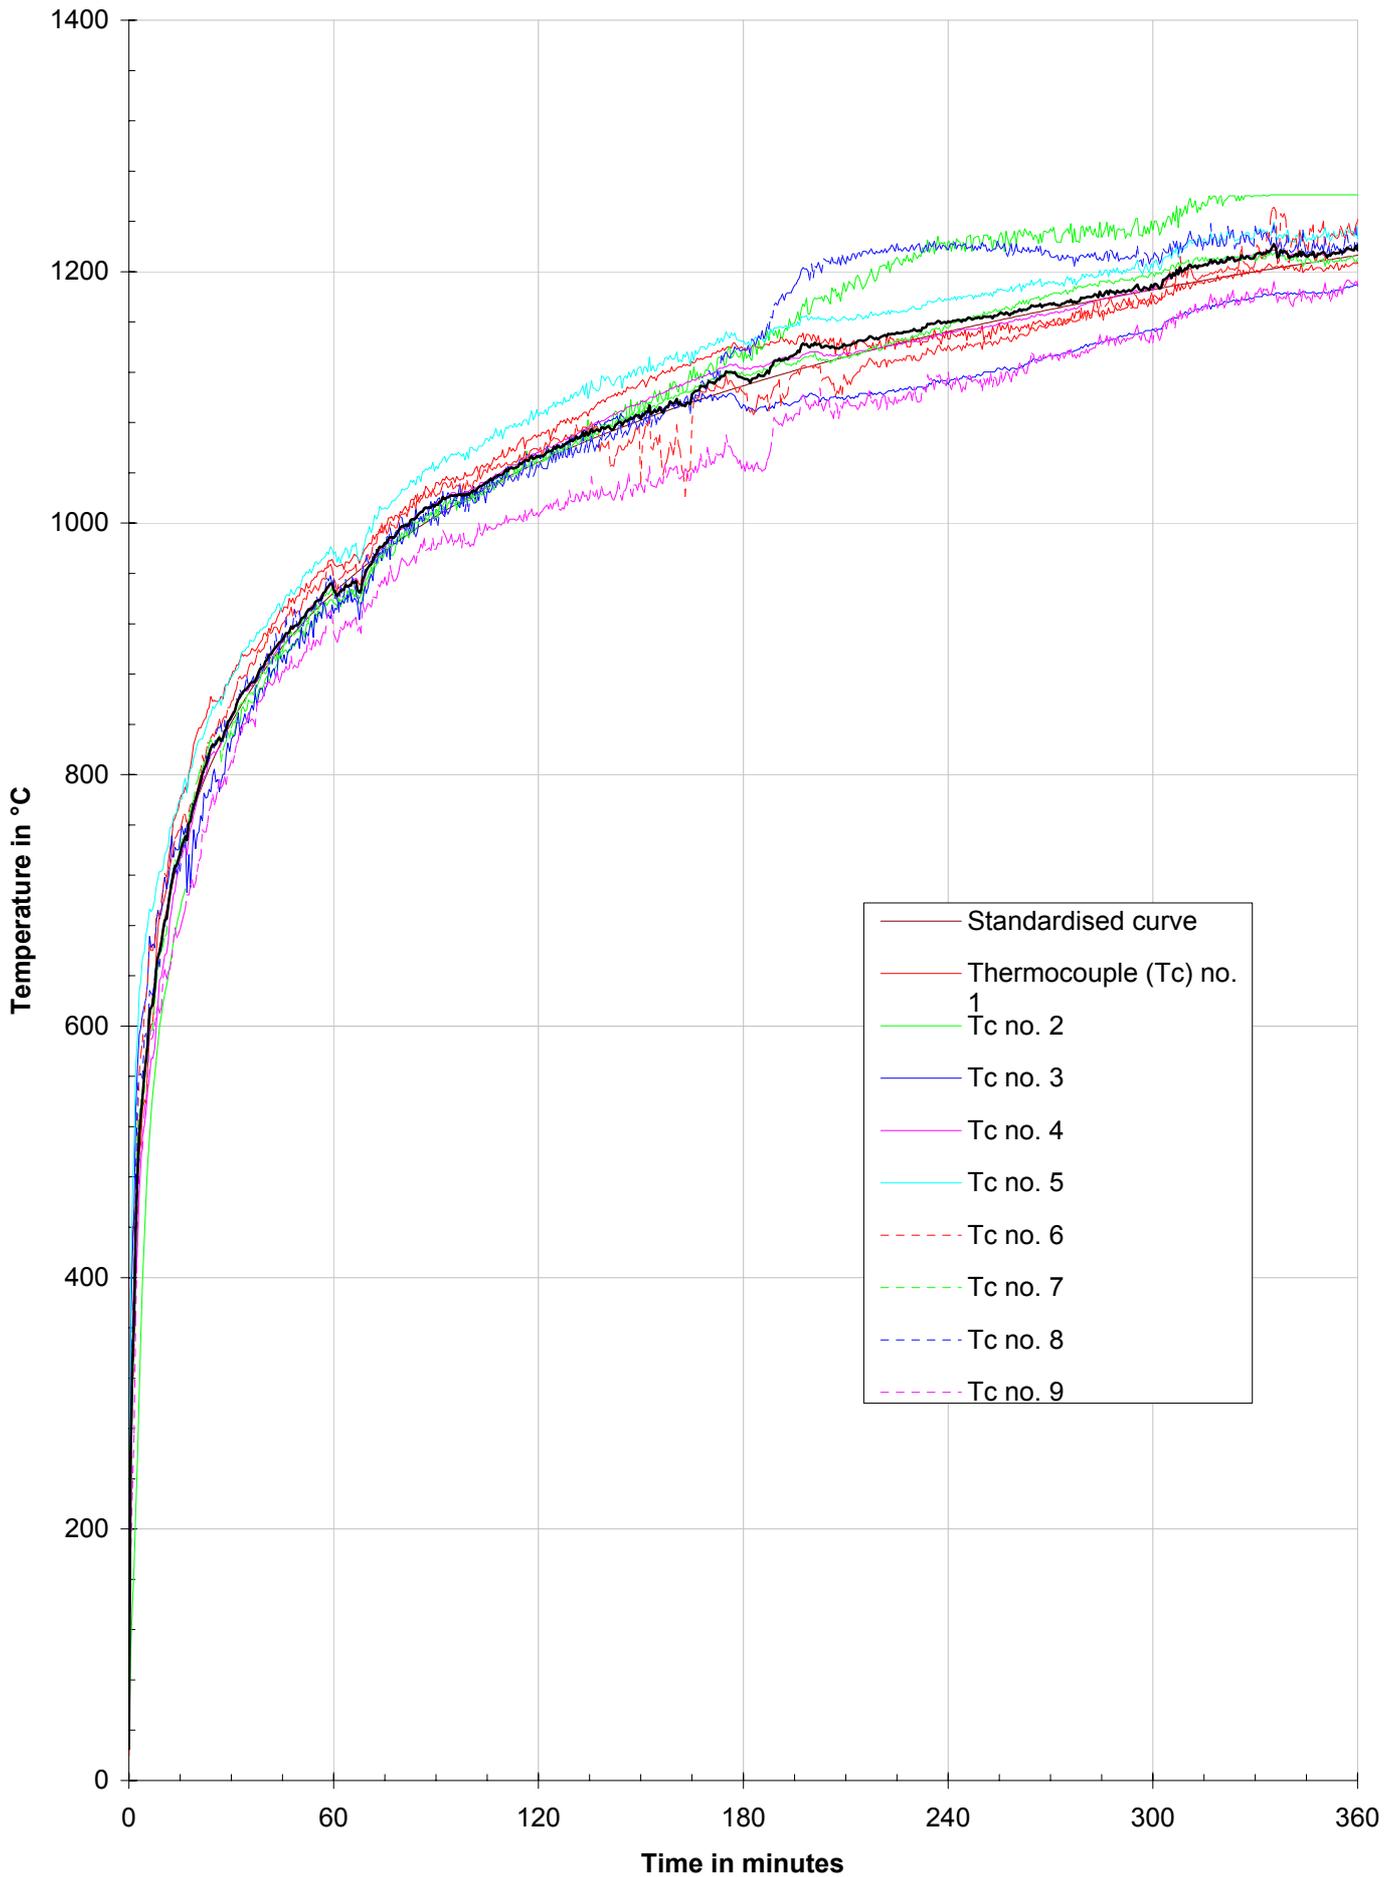
OVEN OPERATION

The thermal programme followed is represented by the following function:

$$T - T_0 = 345 \log (8t + 1)$$

which gives the oven's temperature rise above ambient in degrees C as a function of time in minutes.

The temperatures are measured with the aid of 9 thermocouples (Tcs) and recorded during the test in compliance with Appendix XI of the Decree of August 3, 1999.

- See the recordings, Plate no. 3 -

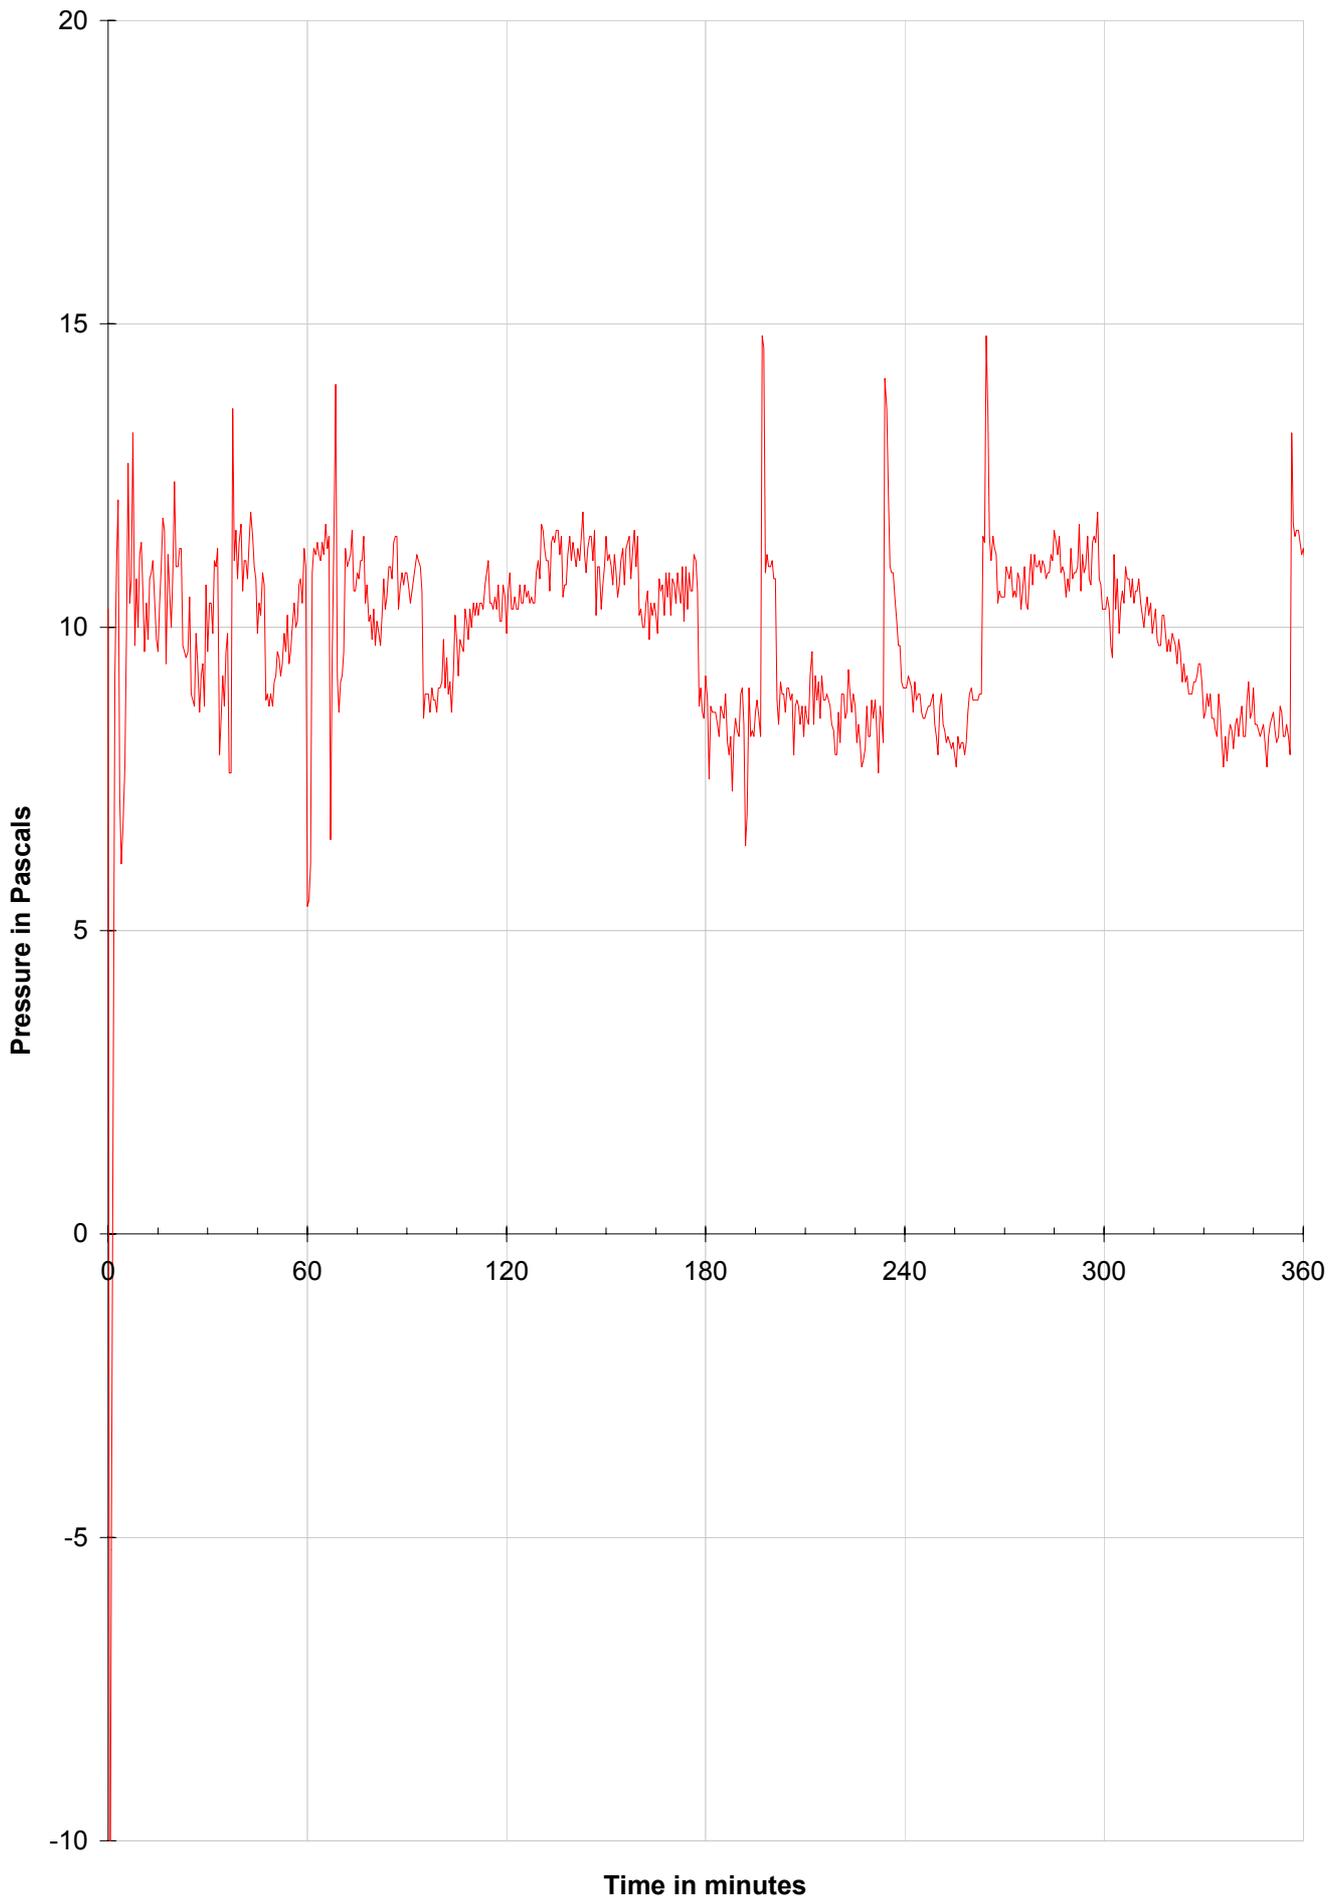
PRESSURE AT THE UPPER PART OF THE ELEMENTS

Over its whole surface, including on its periphery, the test element is subjected to a pressure difference between the inside and the outside of the oven in compliance with Appendix XI of the Decree (10 ± 5 Pa at the upper part of the elements).

- See the recording, Plate no. 8 -

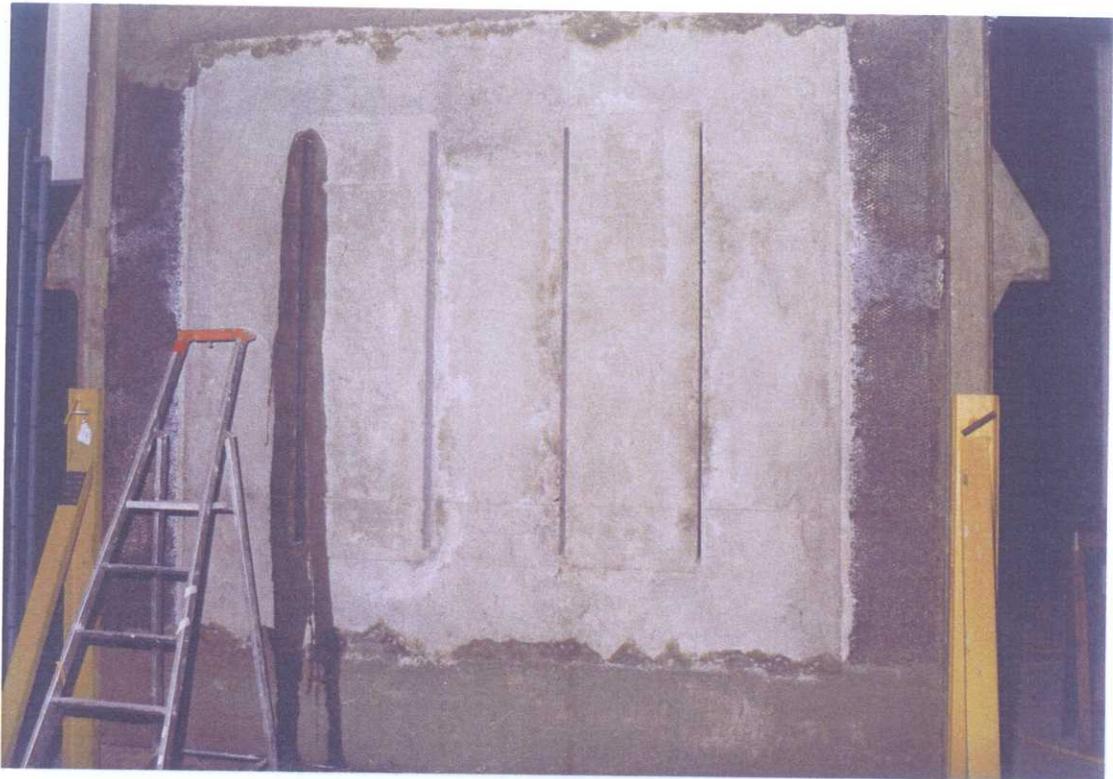
Photo overall of the vertical wall and dampening of the apertures

- See the photos taken during set-up, Plates no. 9 and 10 -

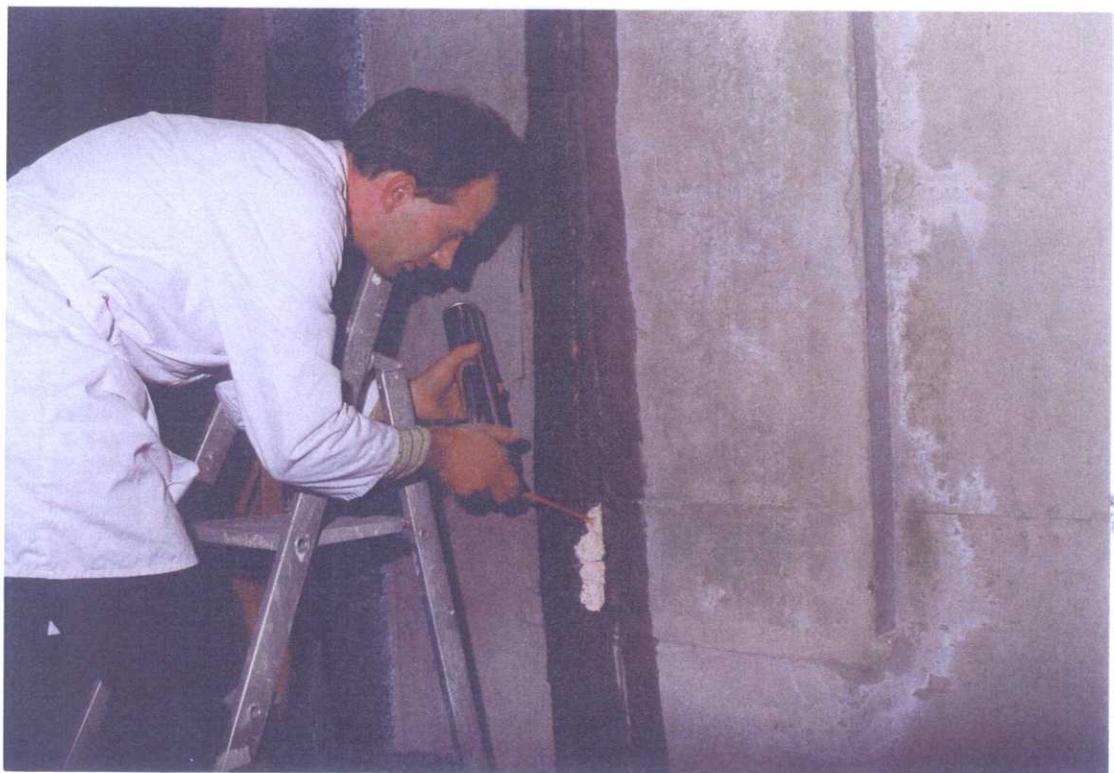
Photo of the face exposed to fire after elimination of the surplus and bringing the seals flush

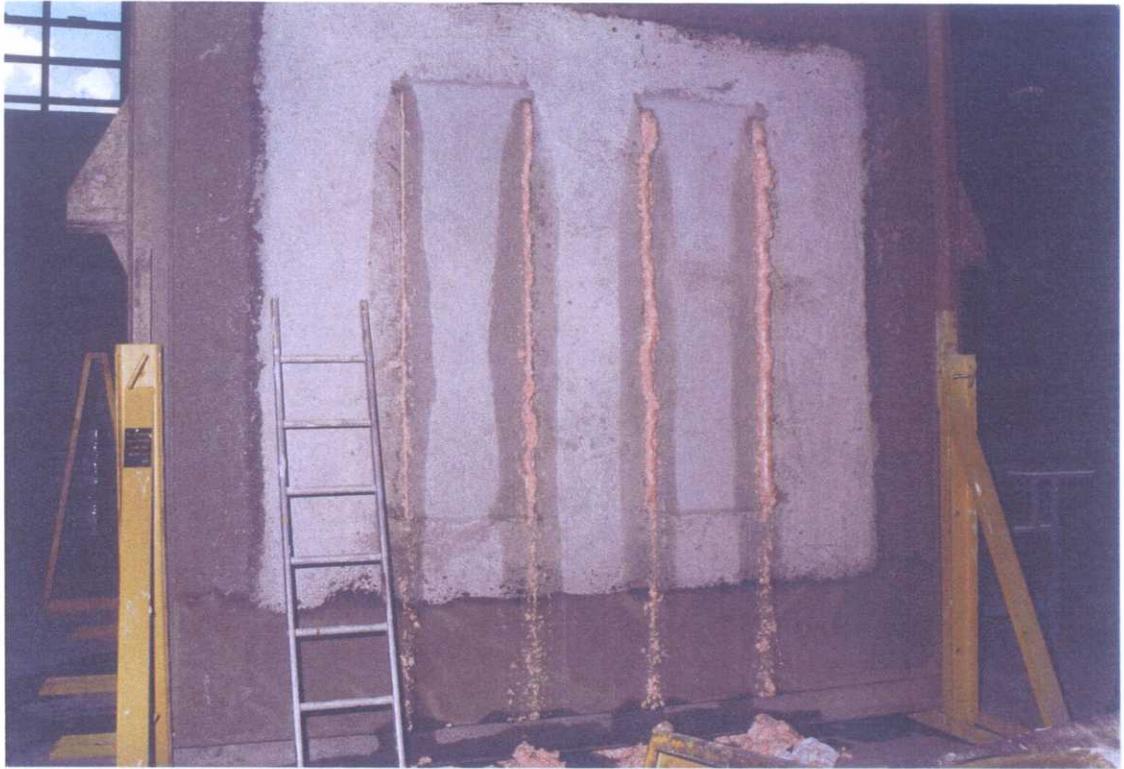
Seal inserted to repletion

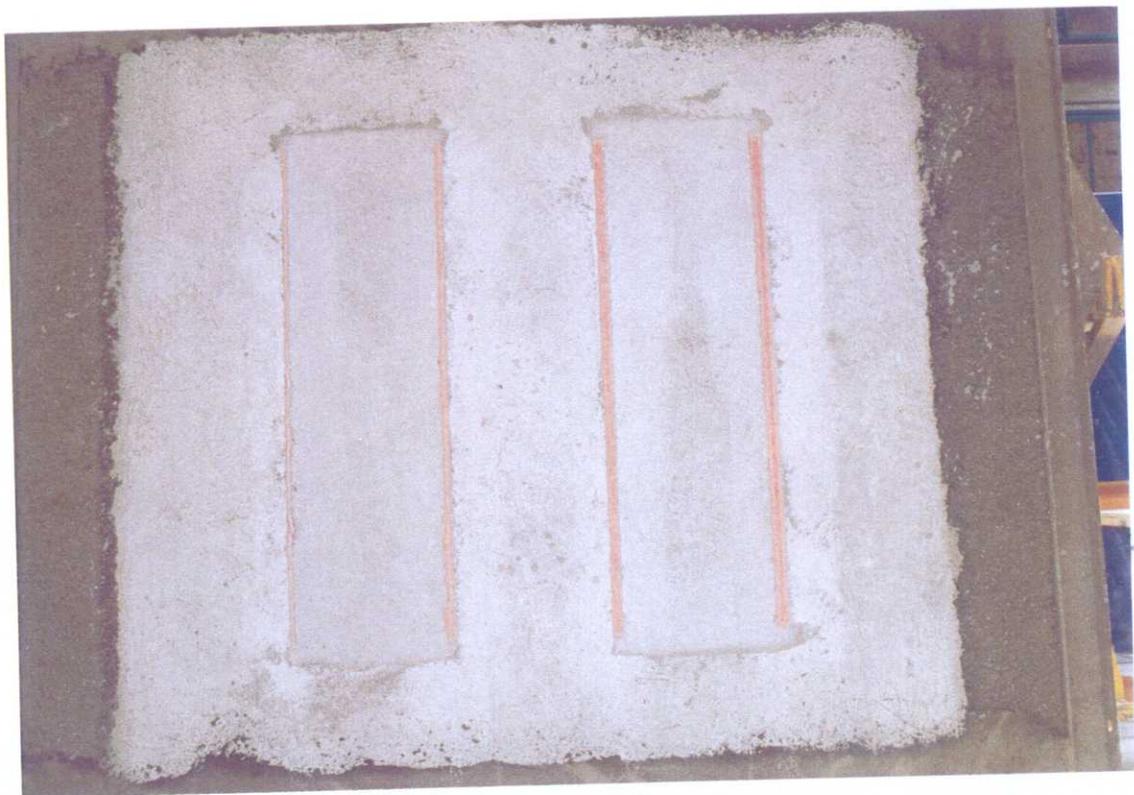
Photo of the face exposed to the fire after elimination of the surplus and bringing the seals flush

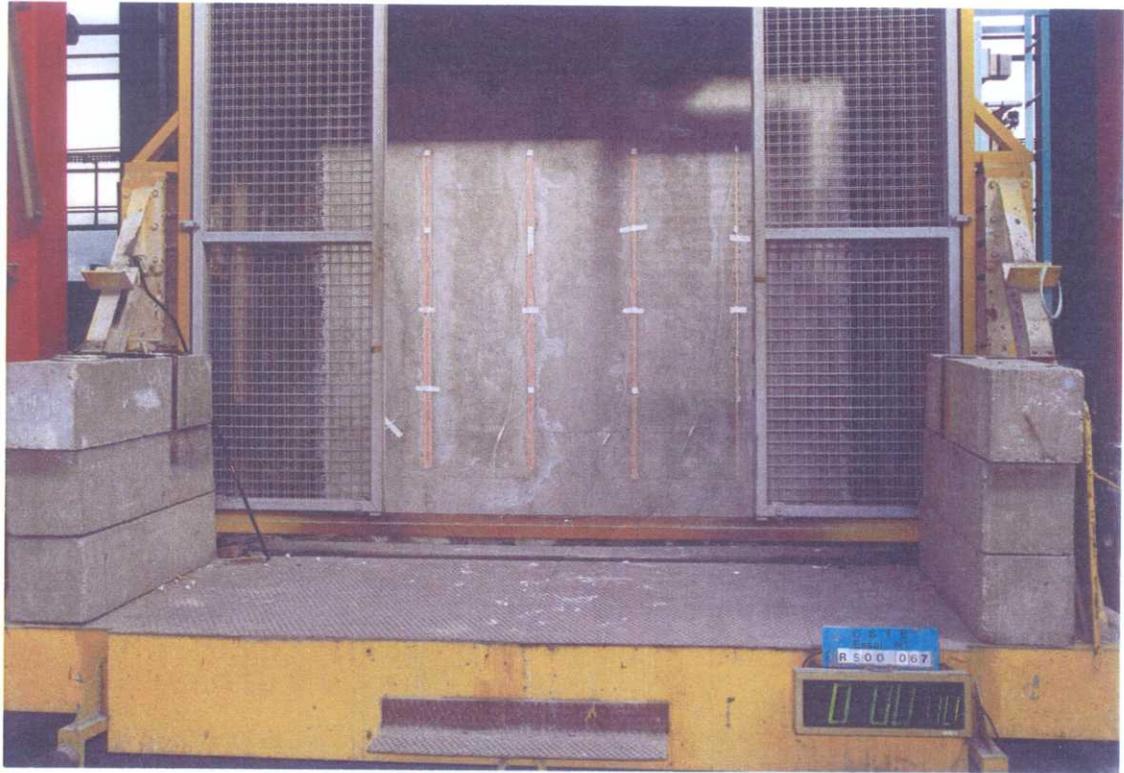
Photo of the face not exposed to the fire at the beginning of the test

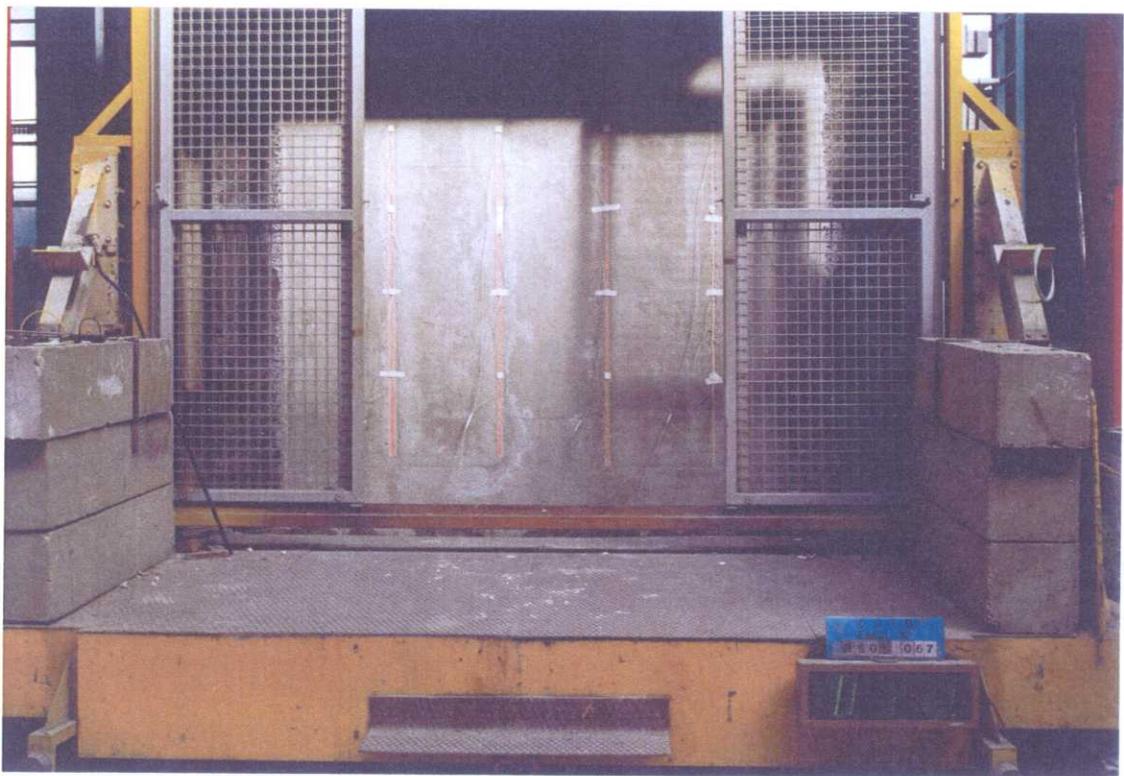
Photo of the face not exposed to the fire at 15 minutes of the test

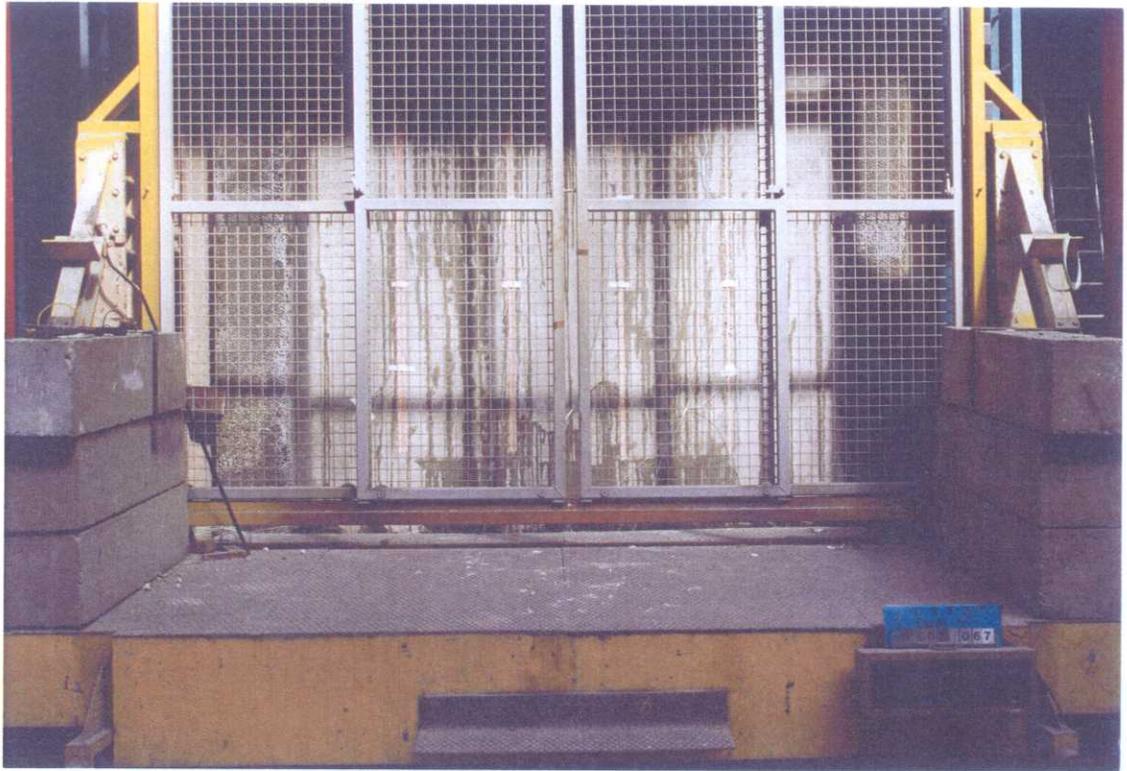
Photo of the face not exposed to the fire at 1 h of the test

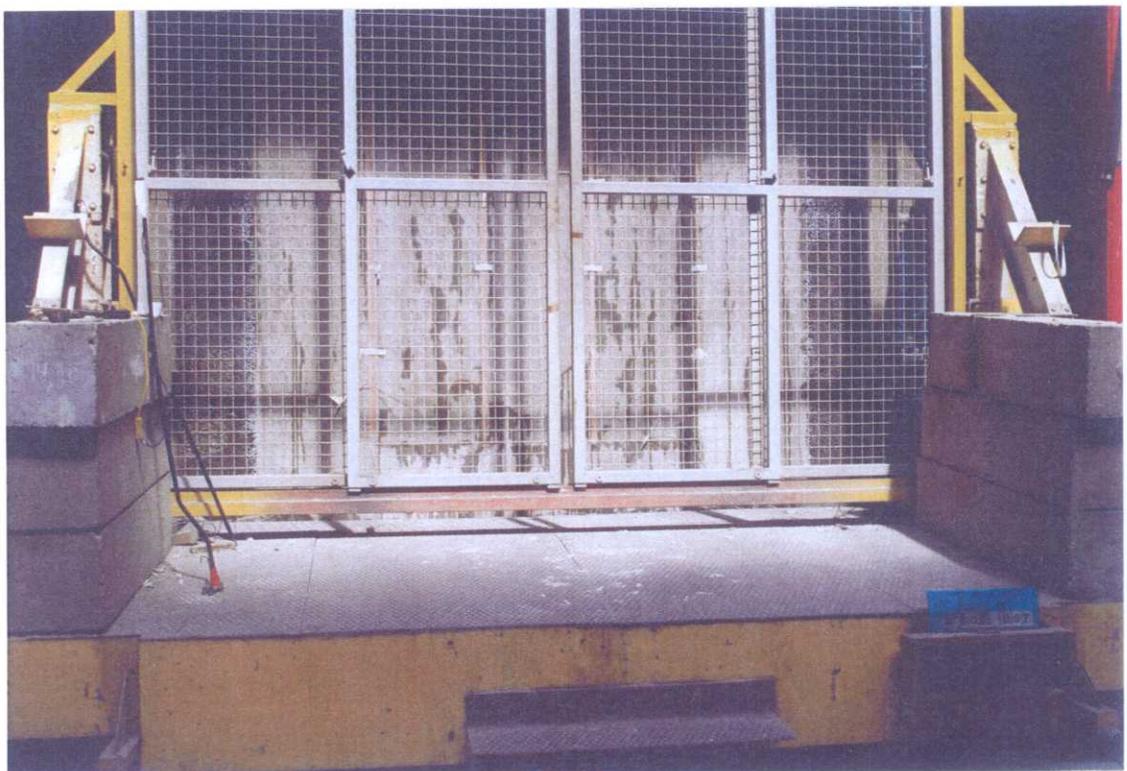
Photo of the face not exposed to the fire at 2 h of the test

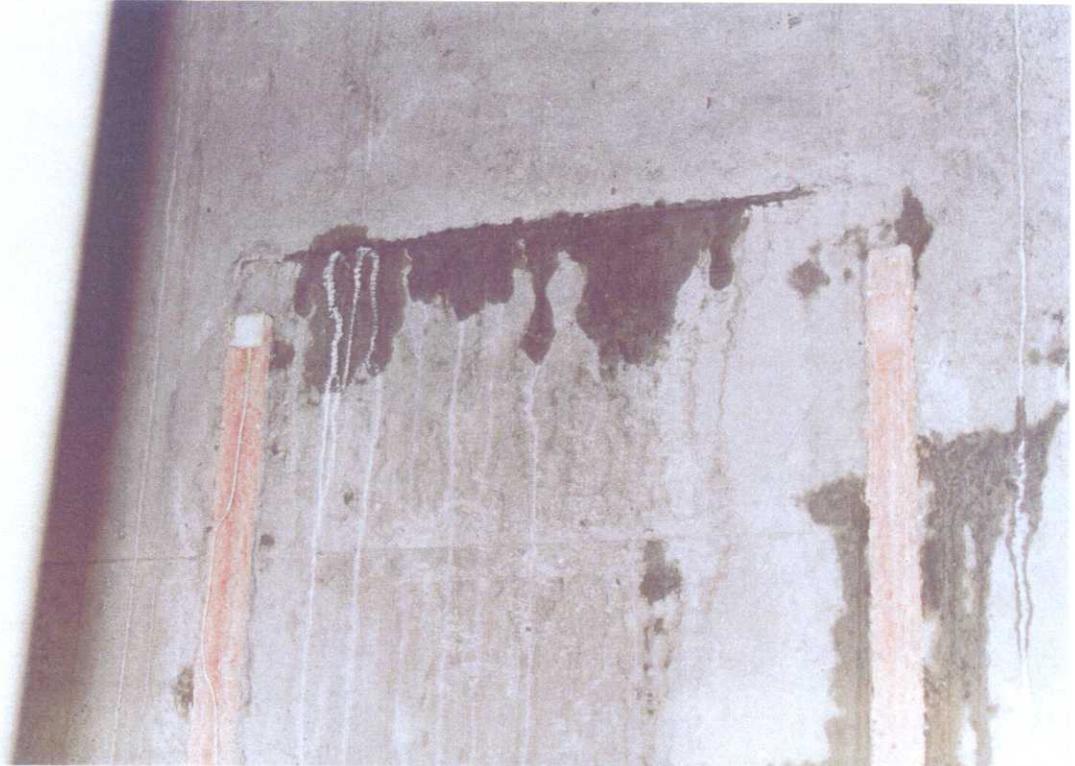
Detail of seal A, 40 mm, and seal B, 30 mm, at 2 h of test

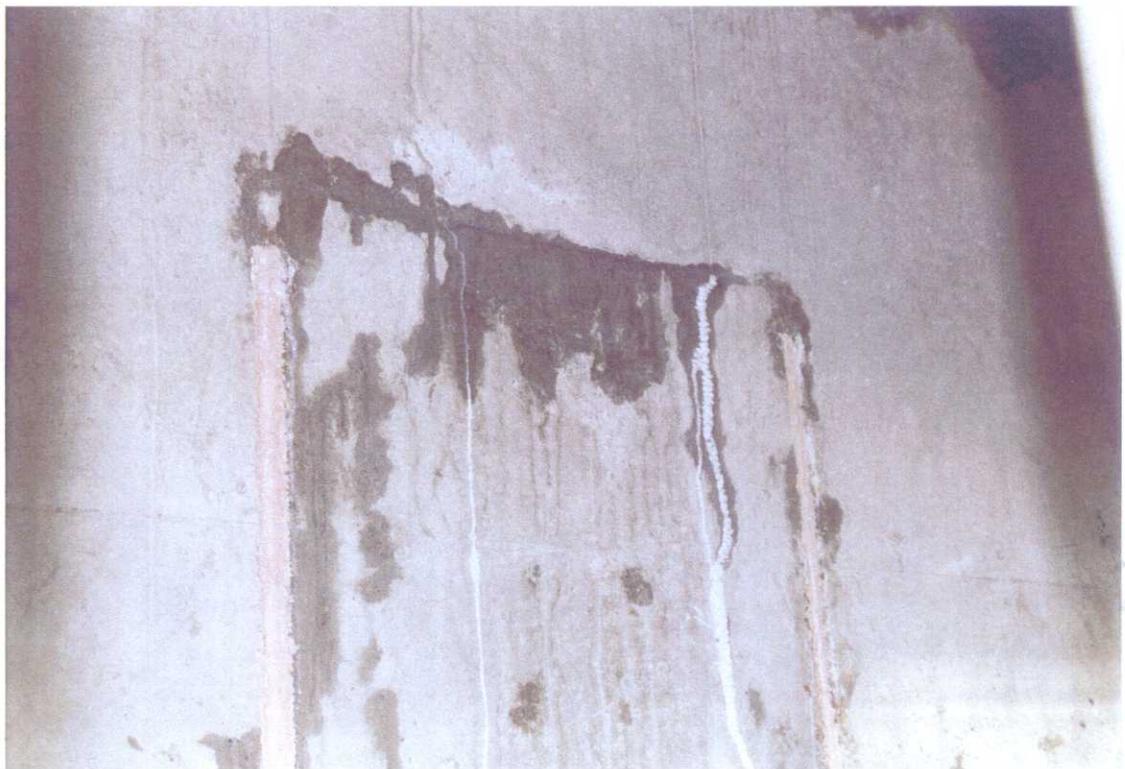
Detail of seal C, 20 mm, and seal D, 10 mm, at 2 h of test

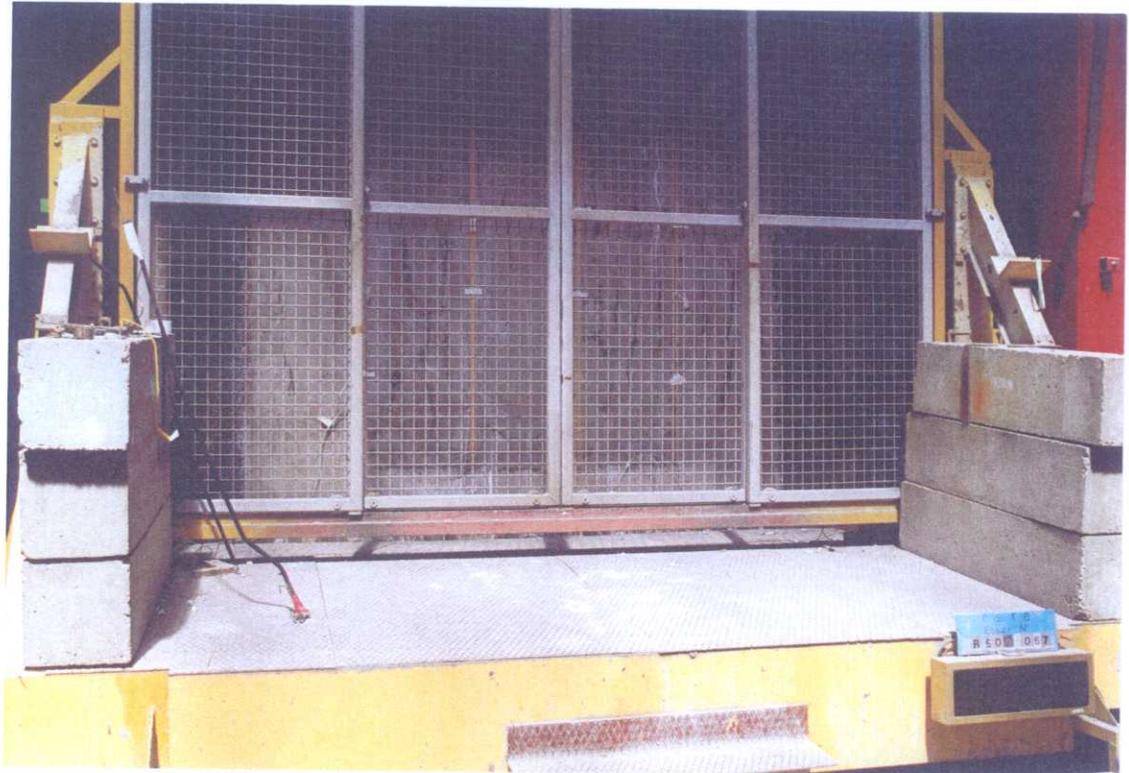
Photo of the face not exposed to the fire at 3 h of test

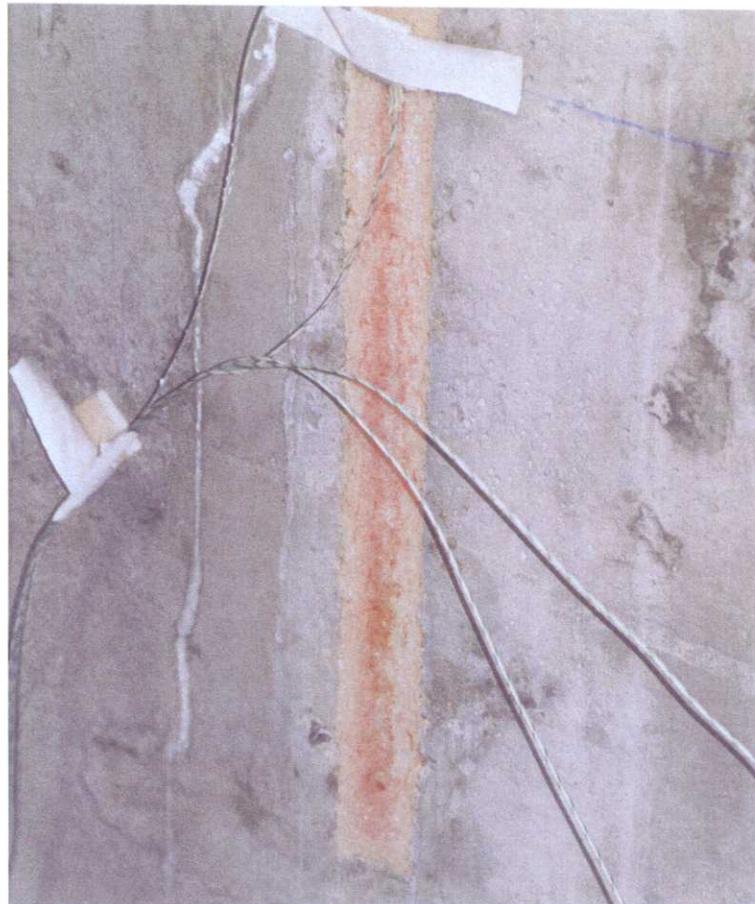
Detail of the brown stain at the lower part of seal A, 40 mm, at 3 h and 30 min. of test

TIME	EXPOSED FACE	NON-EXPOSED FACE
3 h 26		Measurements recorded with the aid of the mobile thermocouple at the upper extremity, seals A, B, C and D: 33.5 °C.
3 h 30 min	A, B, C and D: the seal is drawn back further to about 55 to 60 from the wall's outside surface.	A: at the bottom part, appearance of a brown stain, at about 35 of the concrete, covering from 80 to 100 high.
3 h 33 min		A: blackening of the stain noted at 3 h 30 minutes of the test.
3 h 37 min		Measurements recorded with the aid of the mobile thermocouple at the brown stain of seal A: 47 °C.
3 h 38 min		A: ignition point at the upper part of the seal, then piercing, appearance of the oven. <u>End of heat insulation of seal A, width 40.</u> Gaseous releases, pilot flame test: no flaming.
3 h 49 min		A: second piercing below the first. Gaseous releases, pilot flame test: no flaming.
3 h 50 min		A: gaseous releases at the piercings. Pilot flame test: no flaming.

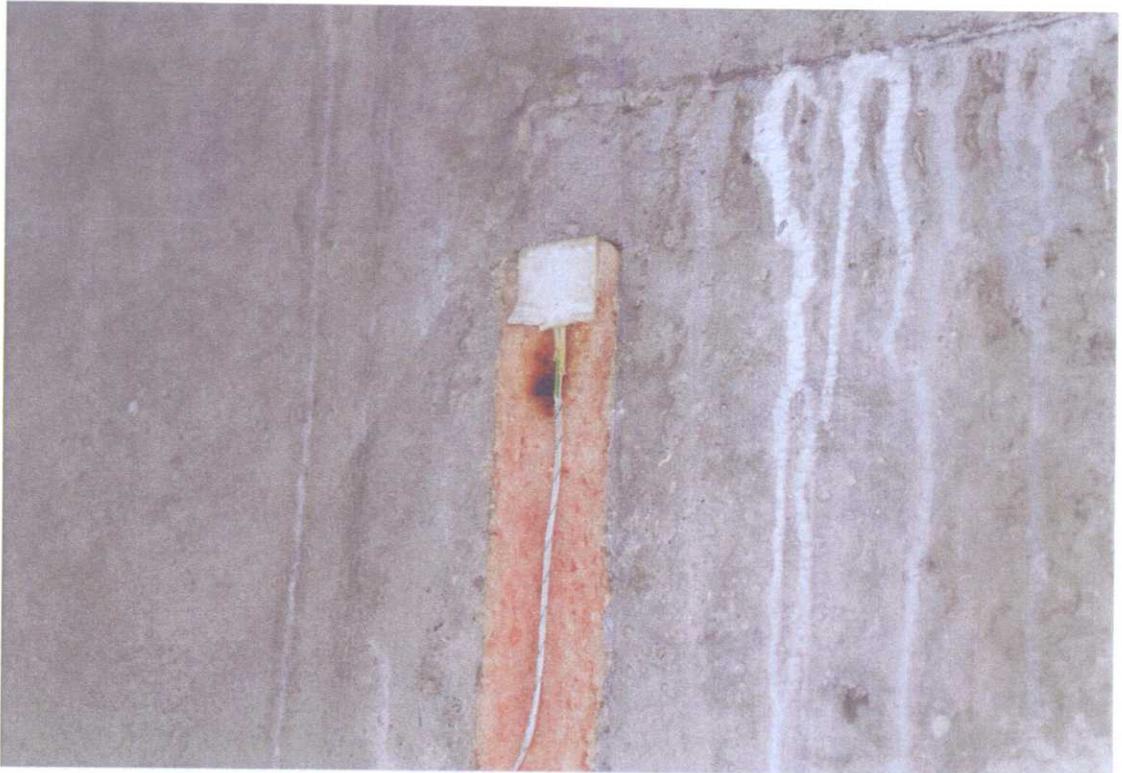
Detail of the beginning of piercing at the upper part of seal A, 40 mm, at 3 h and 38 min. of test

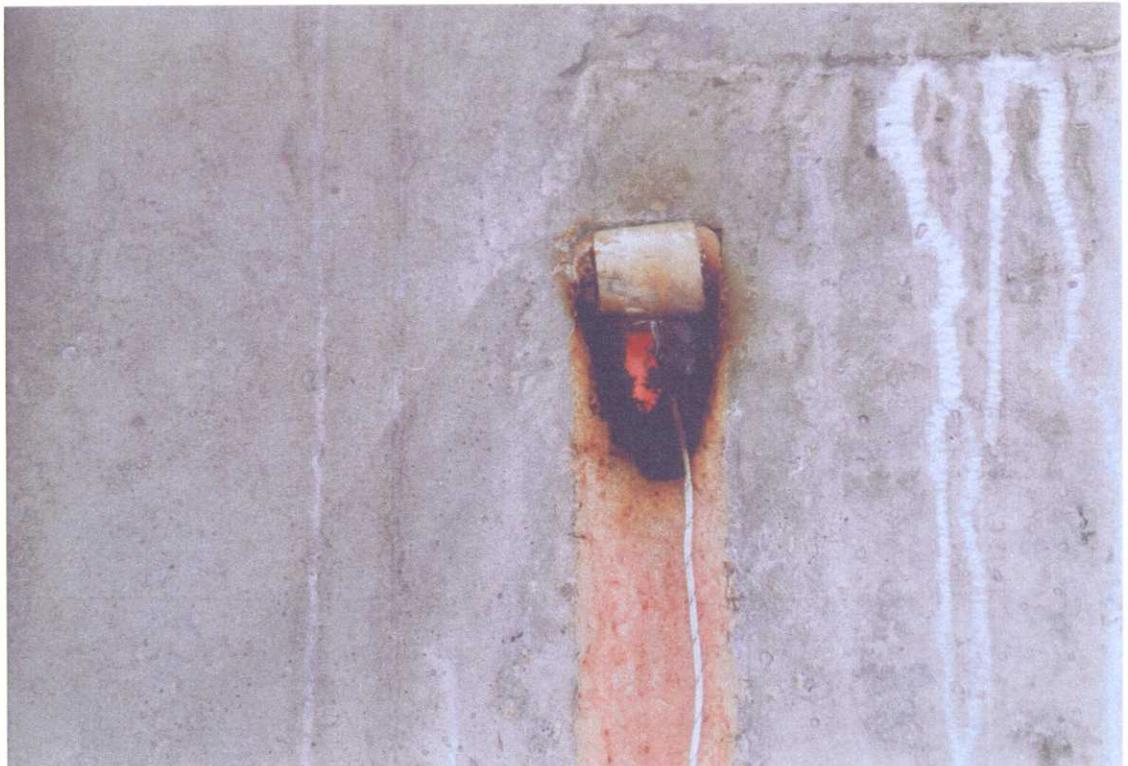
Detail of the opening at the upper part of seal A, 40 mm, at 3 h and 43 min. of test

3 h 52 min		A: third piercing, the opening surface, letting the oven appear, is larger than 45 cm ² . <u>End of width 40 seal A's flame penetration and hot gas containment.</u>
3 h 58 min		Measurements recorded with the aid of the mobile thermocouple at the upper extremity, seals B, C and D: 36 °C.
3 h 59 min		A: The upper quarter of the seal is entirely destroyed. The seal consumes itself and the destroyed zone is extending downward. The flaming is not considerable (candle).
4 h 06 min		Measurements recorded with the aid of the mobile thermocouple at the upper extremity, seals B, C and D: 36 °C.

Duration	232 minutes
Cause of limitation	Opening > 45 cm ²

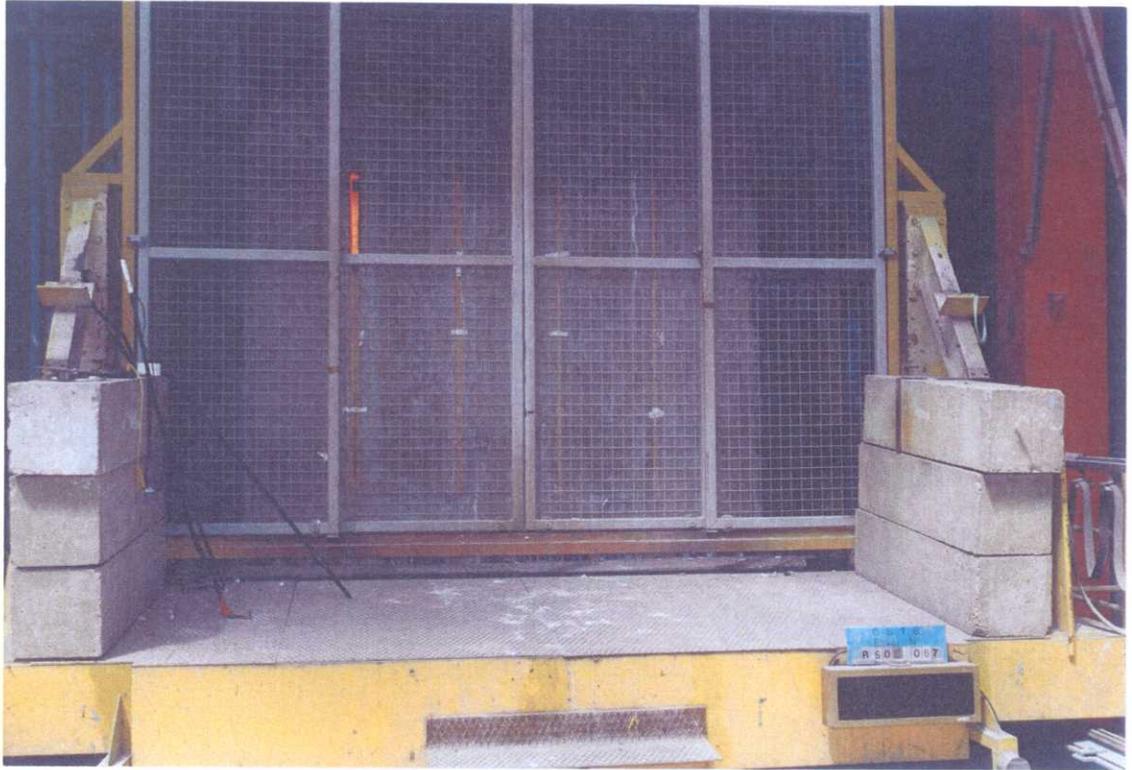
Photo of the face not exposed to the fire at 4 h of test

TIME	EXPOSED FACE	NON-EXPOSED FACE
4 h 15 min		Measurements recorded with the aid of the mobile thermocouple at the upper extremity, seals C and D: 37 °C.
4 h 20 min		<i>Installation of a wool panel by CSTB employees to seal off the opening of seal A.</i>
4 h 25 min		Measurements recorded with the aid of the mobile thermocouple at the upper extremity, seals C and D: 37 °C.
4 h 30 min		B: at the bottom part, appearance of a slightly brown stain.
4 h 43 min		Measurements recorded with the aid of the mobile thermocouple at the upper extremity, seals B, C and D: 36 °C.
4 h 50 min		B: at the upper part, appearance of a brown stain.
4 h 51 min		B: ignition point at the upper part of the seal, then piercing and flaming. <u>End of the heat insulation and of the flame penetration and hot gas containment of seal B, width 30.</u>
4 h 16 min		Measurements recorded with the aid of the mobile thermocouple at the upper extremity, seals B, C and D: 41 °C.
