TEST REPORT No. RS00-067

CONCERNING THE FIRE RESISTANCE

Test of fire resistance of foam seals

Material presented by: Société SOUDAL
Trademark: "SOUDAFOAM – FR"
Manufacturer: Société SOUDAL
Origin: TURNHOUT (Belgium)

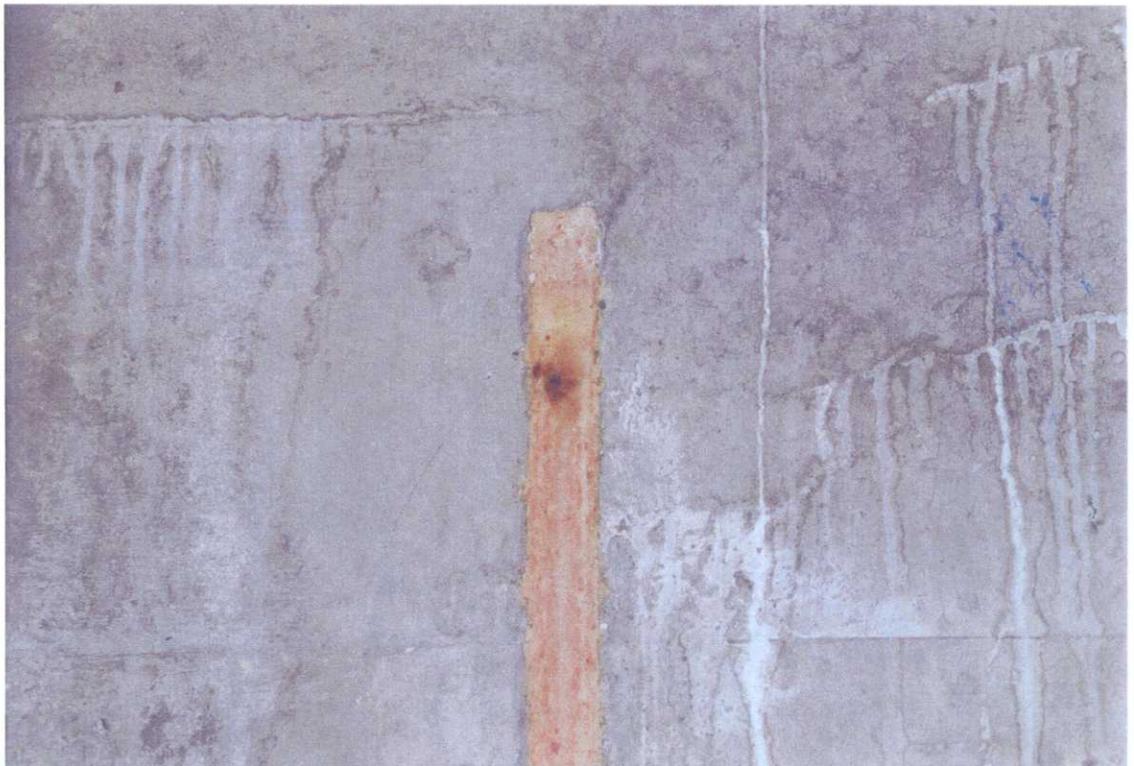
Detail of the beginning of piercing at the upper part of seal B, 30 mm, at 4 h and 51 min. of test

5 h 20 min		B: destruction of the upper 1/7 of the seal.
5 h 50 min		Measurements recorded with the aid of the mobile thermocouple at the upper extremity, seal C: 48 °C and D: 50 °C.
6 h 00 min	<u>TEST IS STOPPED</u>

Duration	291 minutes
Cause of limitation	Opening > 45 cm ²

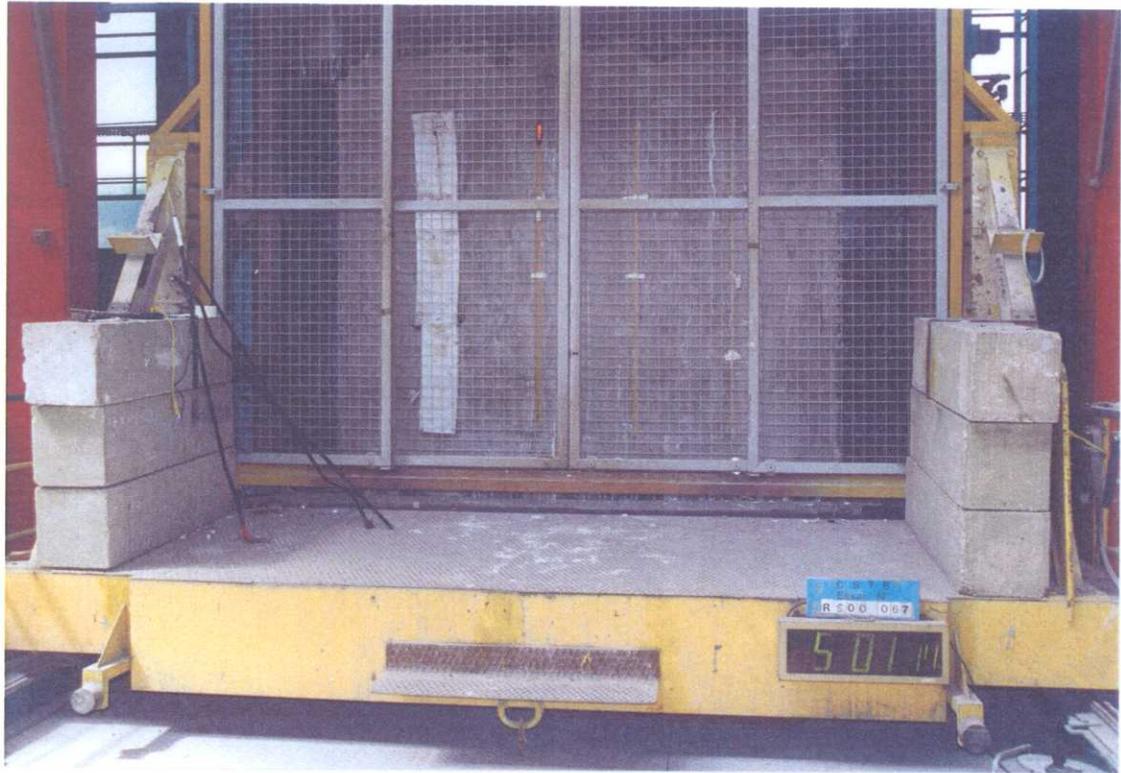
Photo of the face not exposed to the fire at 5 h of test

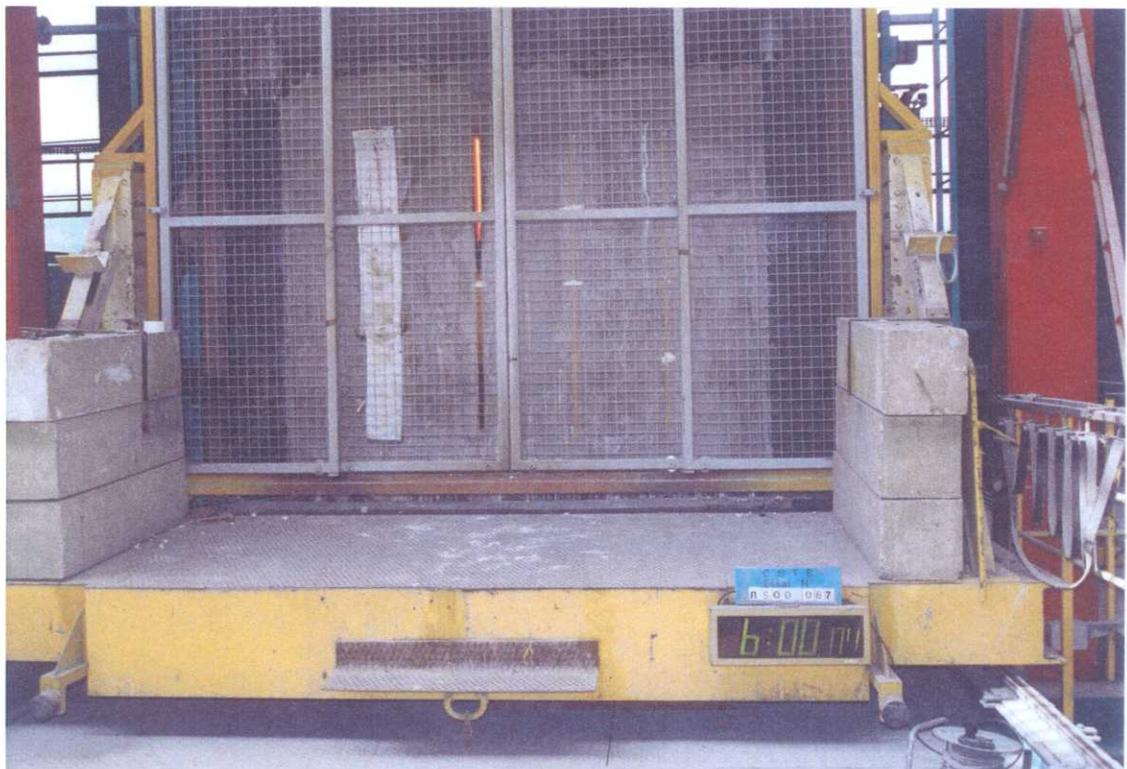
Photo of the face not exposed to fire at 6 h of test

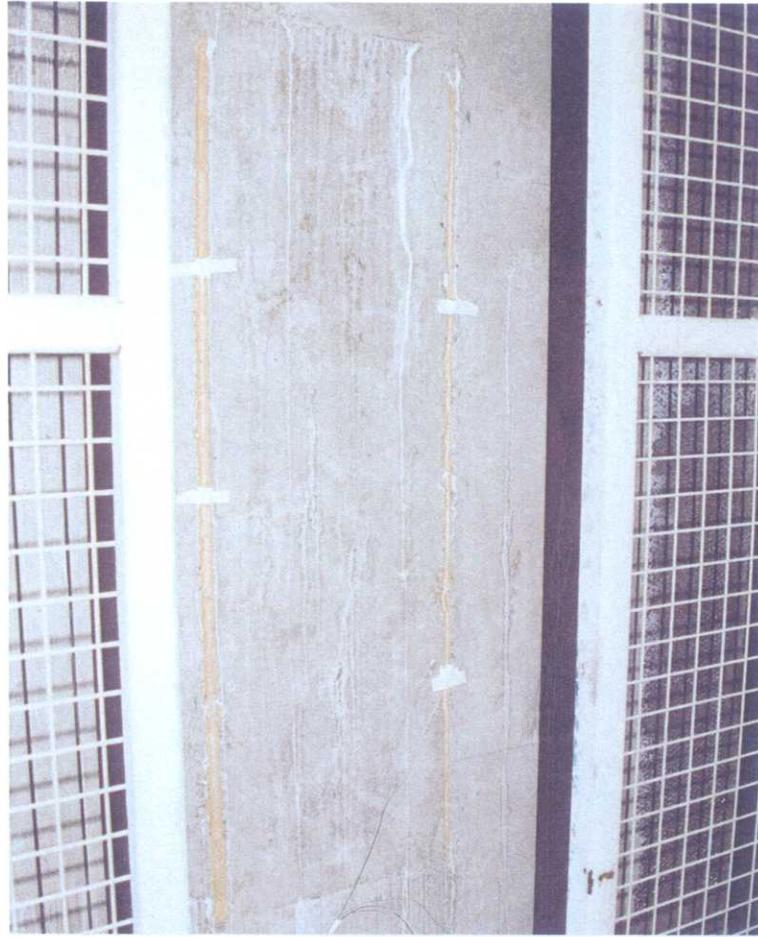
Photo of the face not exposed to the fire at 6 h of test; the test is stopped

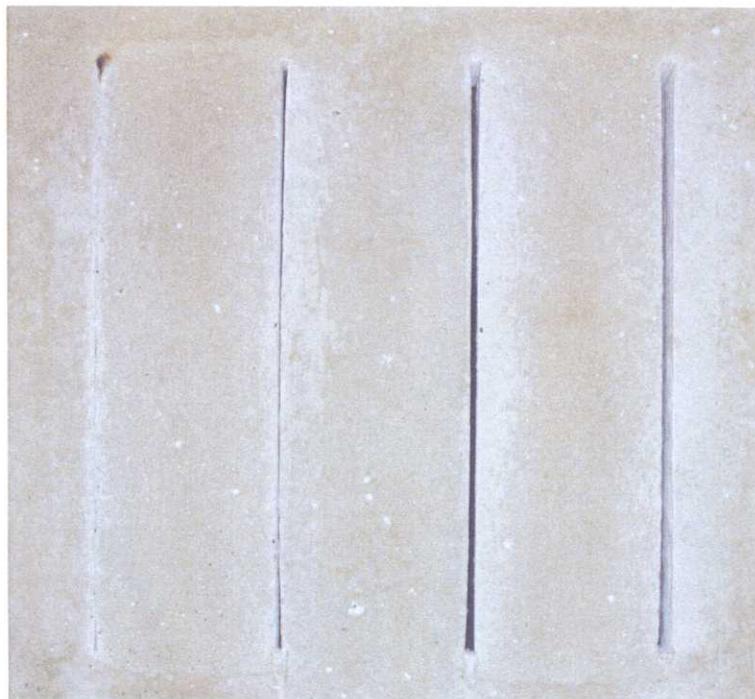
Photo of the face exposed to the fire

- *Seal D, width 10*: the joint aperture is completely reclosed with the concrete deformations.
- *Seal C, width 20*: the two vertical edges are warped toward the inside of the prebuilt aperture. This is reduced to a width of 7 halfway up and to 13 at the extremities. Over the whole surface, there remains a seal thickness of 35 on the exposed face side.
- *Seal B, width 30*: the two vertical edges are warped toward the inside of the prebuilt aperture. This is reduced to a width of 20 halfway up. On the lower half, there remains a seal thickness of 30 on the non-exposed face side.
- *Seal A, width 40*: the two vertical edges are warped toward the inside of the prebuilt aperture. This is reduced to a width of 24 halfway up. Total destruction of the seal.

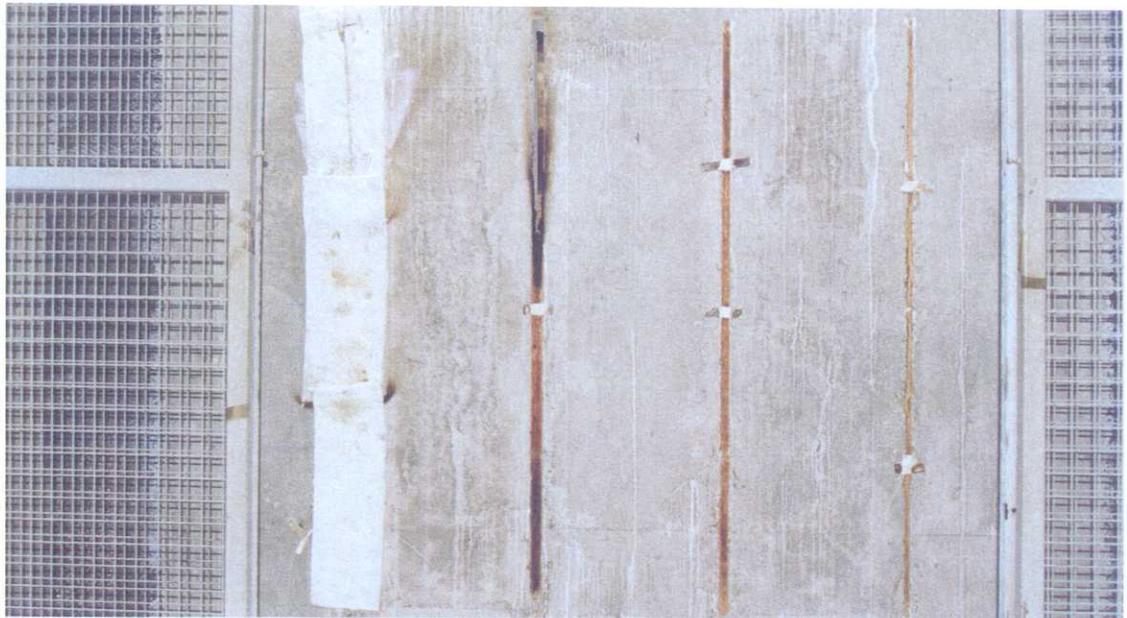
Photo of the face not exposed to the fire

- *Seal D, width 10*: flexible and brown colour.
- *Seal C, width 20*: flexible and brown colour with a black stain at each extremity.
- *Seal B, width 30*: destruction covering 750 at the upper part and at the lower quarter. The remainder is flexible and brown.
- The apertures have widths identical to the initial dimensions.

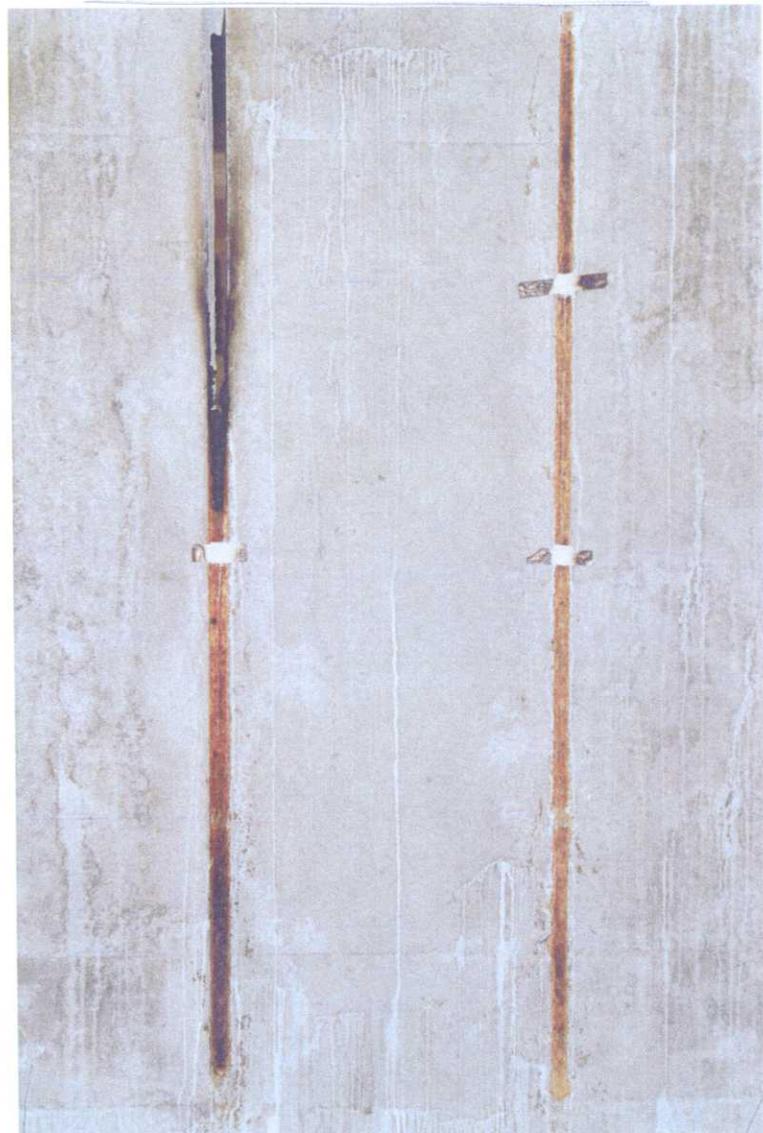
Detail of seals C and D, 20 and 10 mm

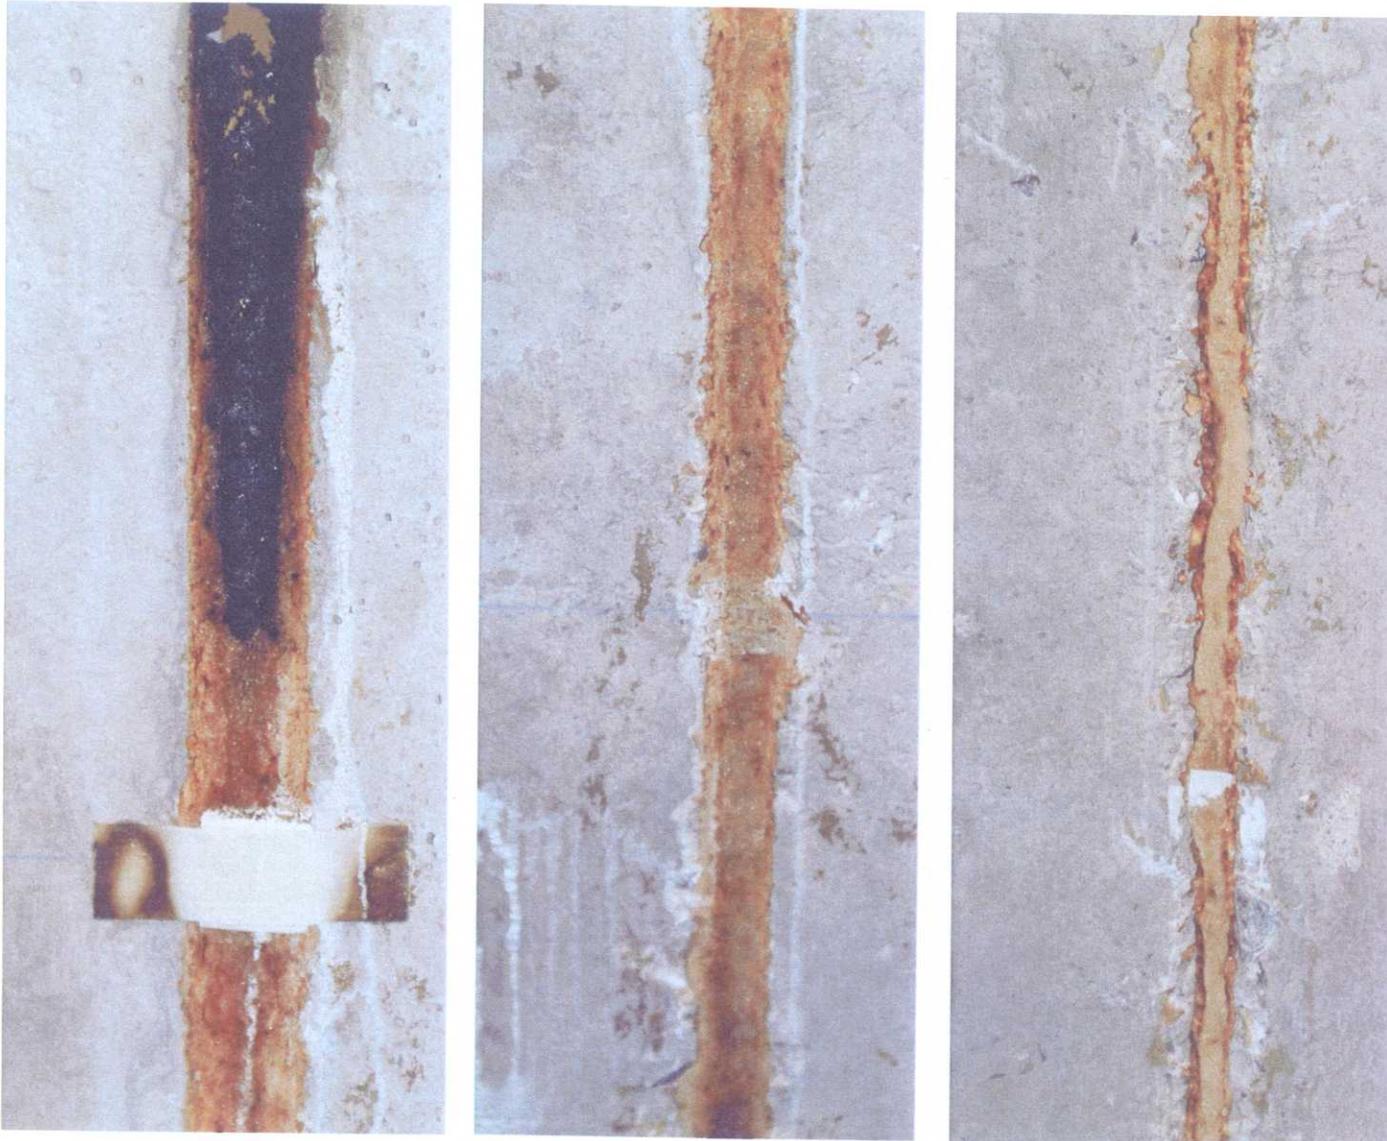
Detail of seals B, C and D, 30, 20 and 10 mm
